Inspection Report Minerals Regulatory Program March 20, 2013

Mine Name: Copperton Concentrator	Permit Number: M/035/0011
Operator Name: Kennecott Utah Copper	Inspection Date: May 09, 2012
Inspector(s): L Heppler, P Brinton	Time: 11:00 am
Other Participants: Zeb Kenyon - Kennecott	Mine Status: Active

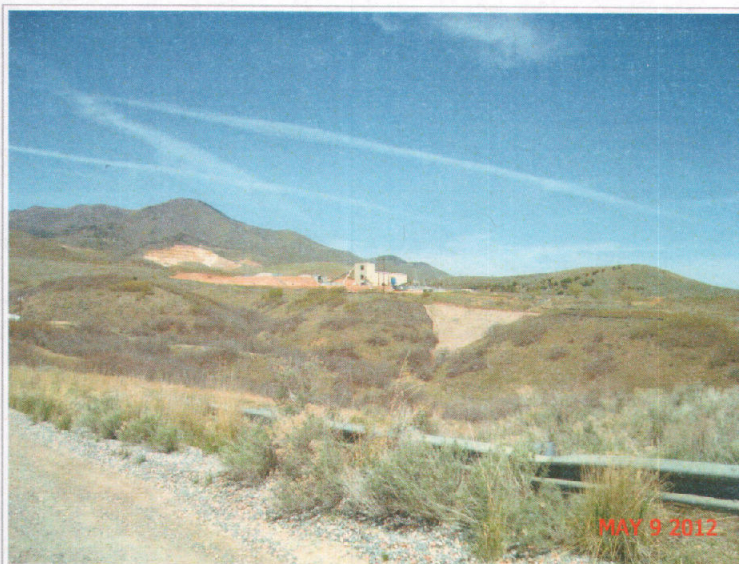
Ore sorter in the distance

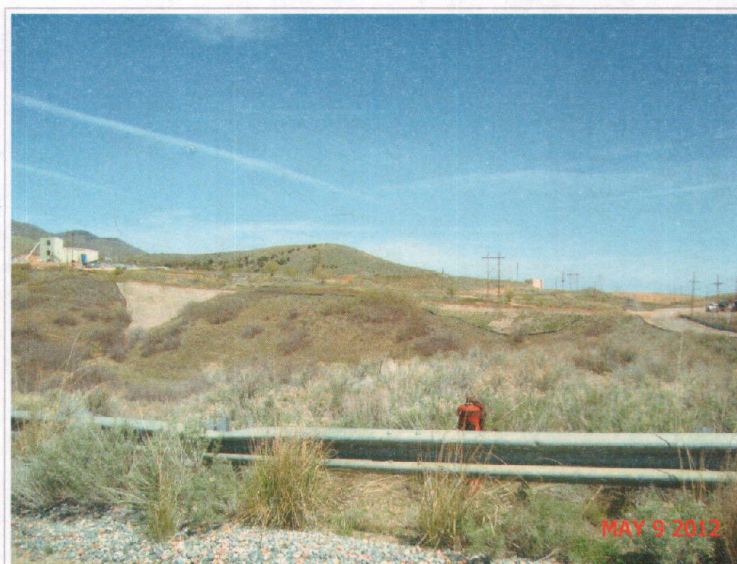
Area below the ore sorter

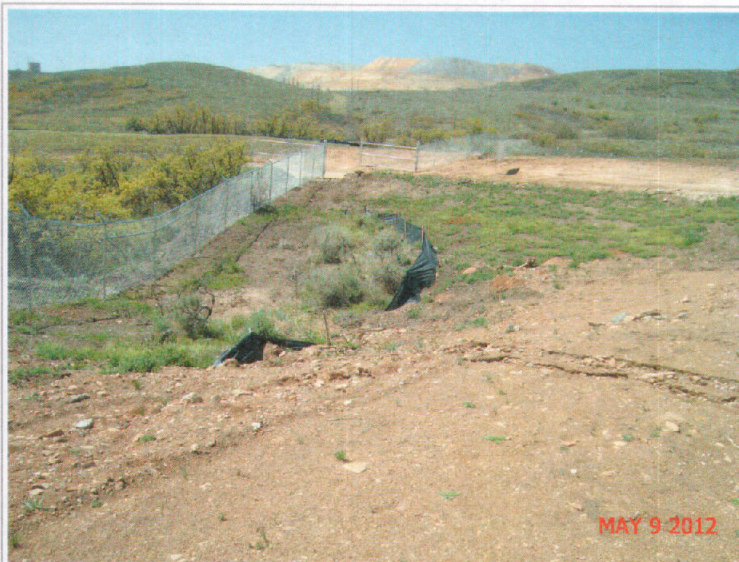
Inspection Summary: This inspection concentrated on the new ore sorter. Access to site was limited by a gate. Permit site was clean and well maintained. No trash was noted on site, and only minimal bone yards. No erosional problems were noted, but a silt fence was down, but nothing had left the site. Concurrent reclamation is not feasible at this time, but operator has maintained a minimal disturbance without impacting either production or safety.

Below rip rap, note silt fence is down

Conclusions and Recommendations: Discussed with Operator fixing the silt fence. Operator committed to fix silt fence. OGM to continue annual inspections, monitor the site when in the area and review the area of the silt fence.

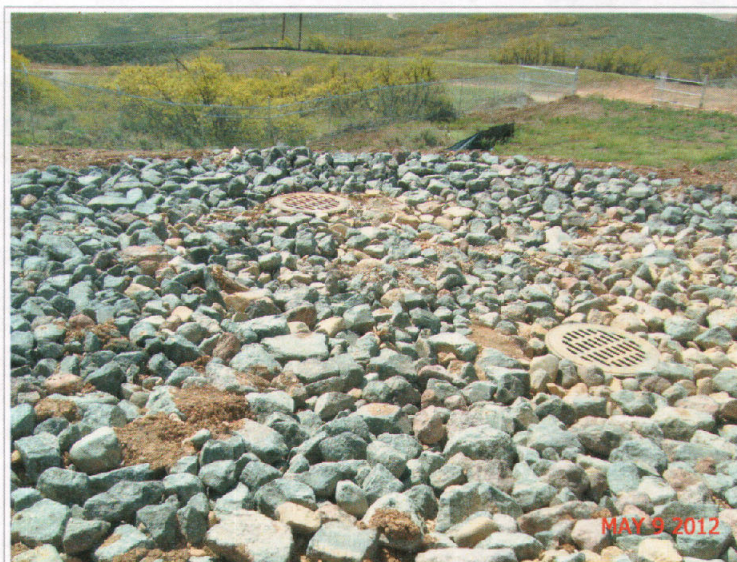
Rip rap area above silt fence
